***National Pollutant Discharge Elimination System  
(NPDES) Inspection Report***

***Hecla Ltd.  
Lucky Friday Mine and Mill***

***NPDES Individual Discharge Permit: ID0000175***

***Multi-Sector General Permit for Stormwater  
Discharges from Industrial Facilities (MSGP)  
NPDES Tracking Number: IDR053139***

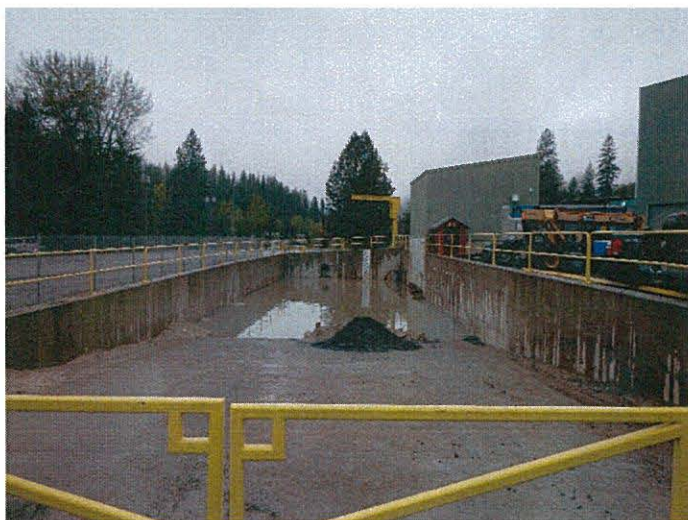
Photo #:01

Description: Photo taken of one of the stormwater controls used the facility. A concrete stormwater basin that receives stormwater from the mine/mill area.

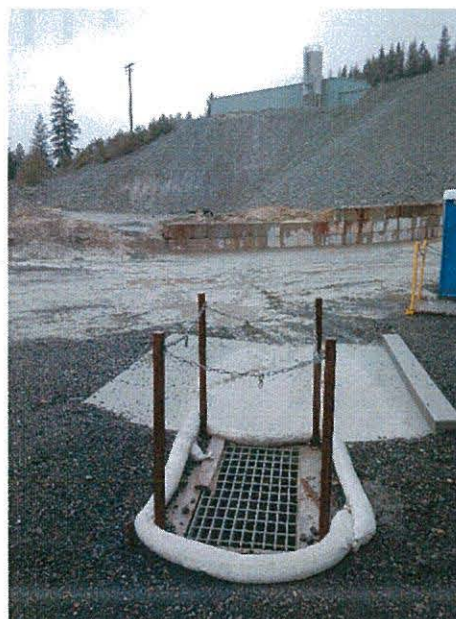
Photo #:02

Description: Photo taken of a stormwater catch basin that receives runoff from a material storage area. Water is routed to a concrete stormwater basin.

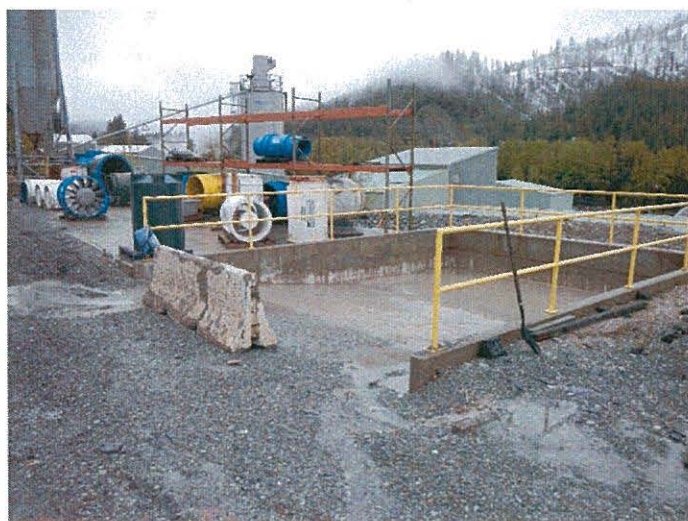
Photo #:03

Description: Photo taken of another concrete storage basin that receives stormwater from the mine/mill area.

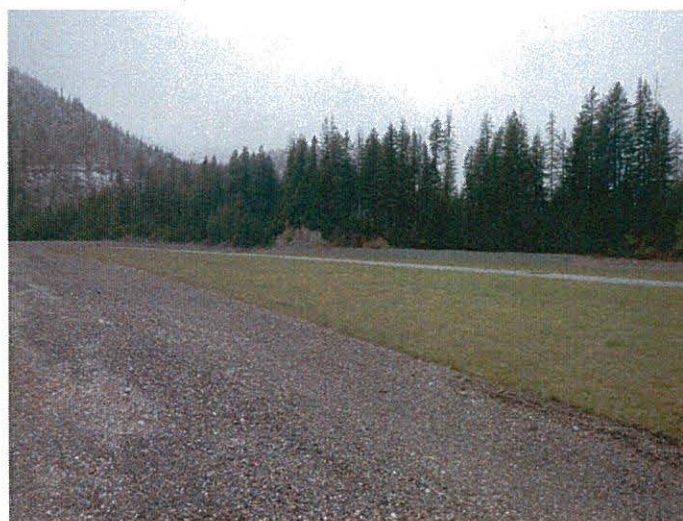
Photo #:04

Description: Photo taken of reclaimed Pond 1.

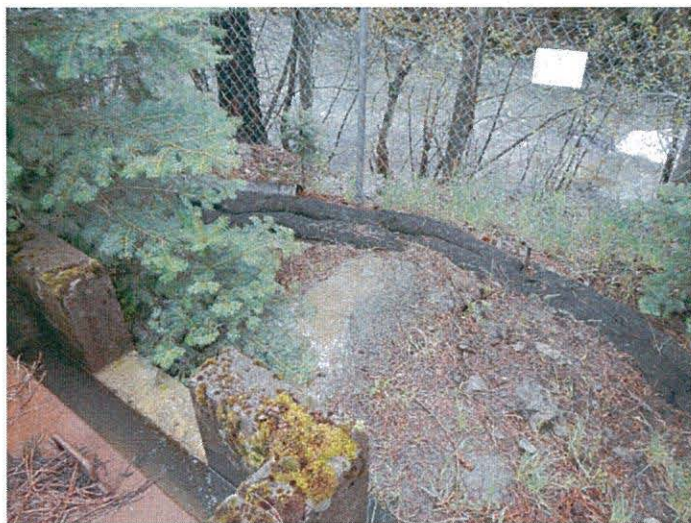
Photo #:05

Stormwater Outfall 1 which covers the surrounding areas around Lucky Friday's remediated Tailings Pond 2 (TP2) was the only outfall discharging at the time of inspection. According to the facility, Outfall 1 is typically the only outfall that will occasionally discharge, most often stormwater is infiltrated at this location. The area is primarily used for light, temporary material storage, including plastics, metals and wood. Due to the occasional metals storage, Lucky Friday utilizes a Storm Clean® catch-basin insert by CleanWay equipped with MetalZorb metals removal media as well as silt fencing and waddles for BMP's.

Description: Photo taken of stormwater Outfall 1, discharging at the time of inspection to the South Fork of the Coeur d'Alene River near NPDES Outfall 002.

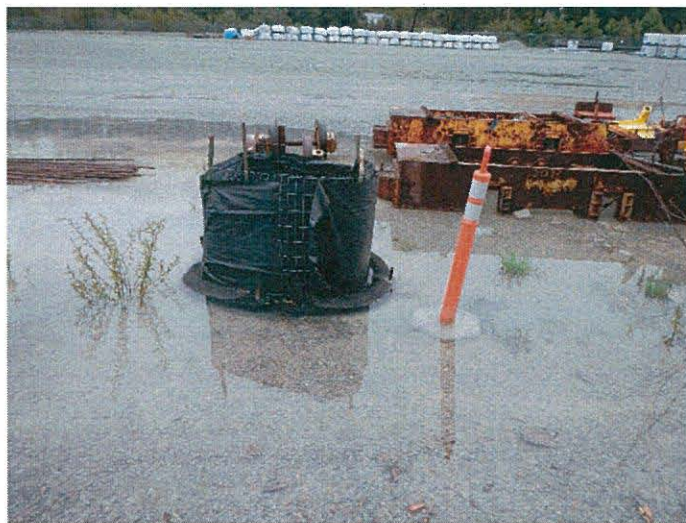
Photo #:06

Description: Photo of the catch basin that serves stormwater Outfall 1.

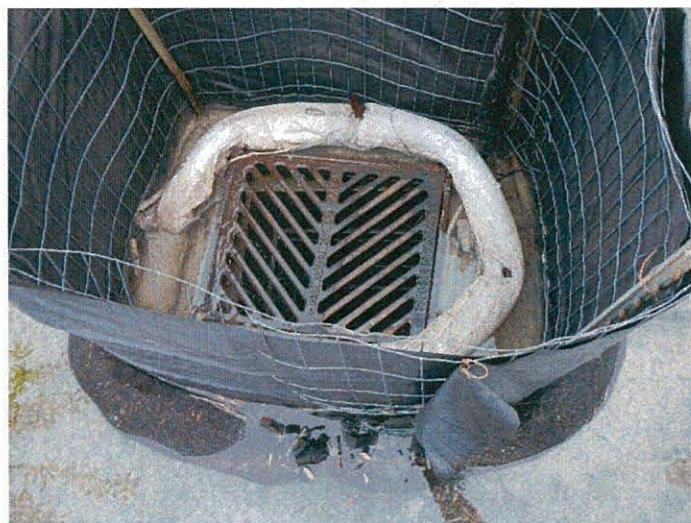
Photo #:07

Description: Photo of the catch basin that serves stormwater Outfall 1.

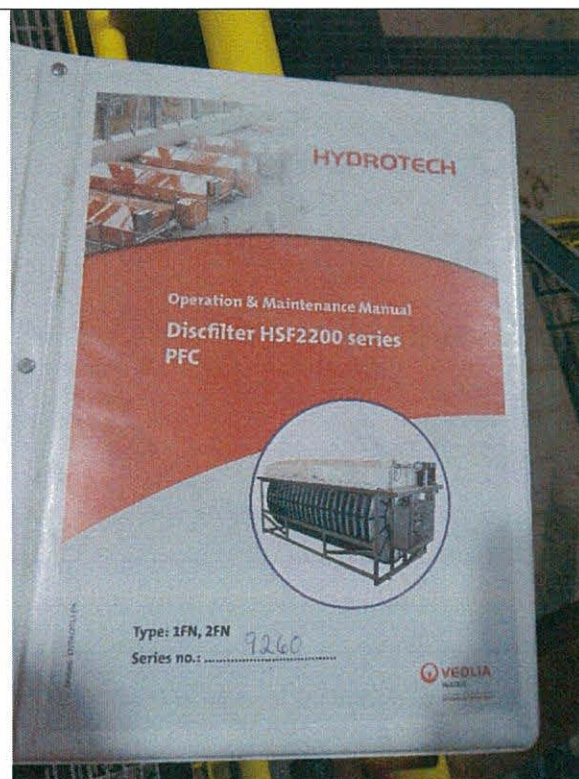
Photo #:08

Description: Photo of the O&M Manual for the new disc filter at WWTP3.

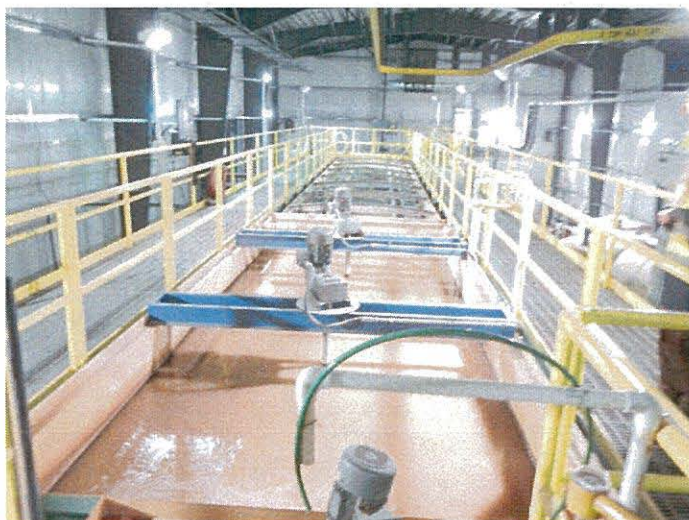
Photo #:9

Description: Photo taken from inside WWTP3.

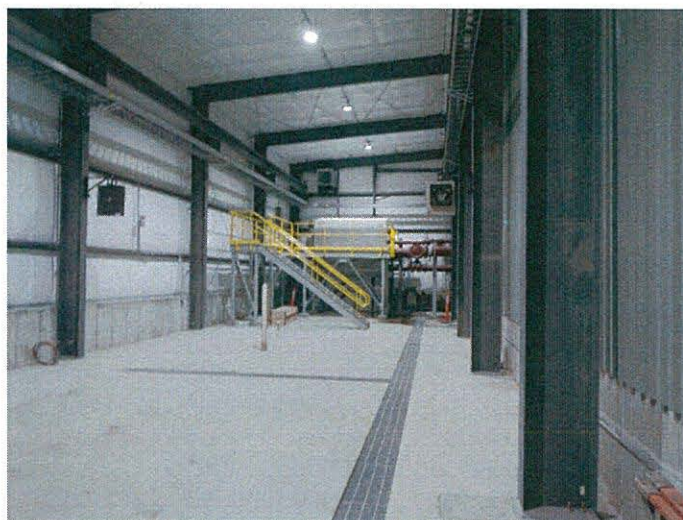
Photo #:10

At the time of the inspection the facility was testing a new disc filter (HSF2200 series) at Outfall 003 that was installed in January 2017, with future plans for a secondary filter and thickening tank.

Description: Photo taken of new disc filter location at WWTP3.

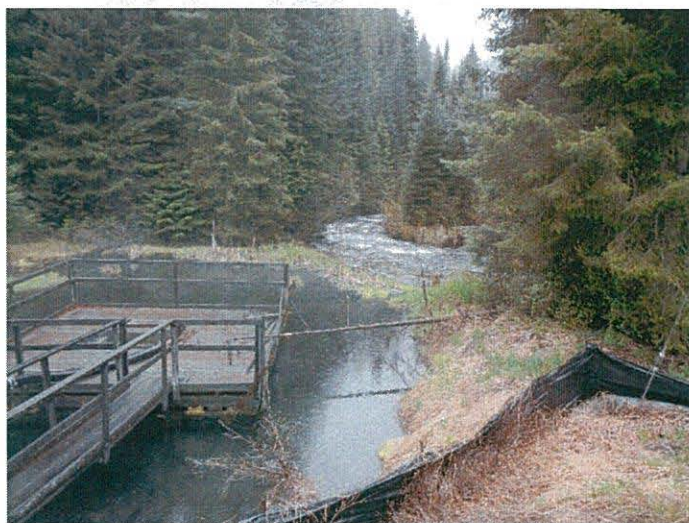
Photo #:11

Description: Photo taken from the location of Outfall 003 to the South Fork of the Coeur d'Alene River

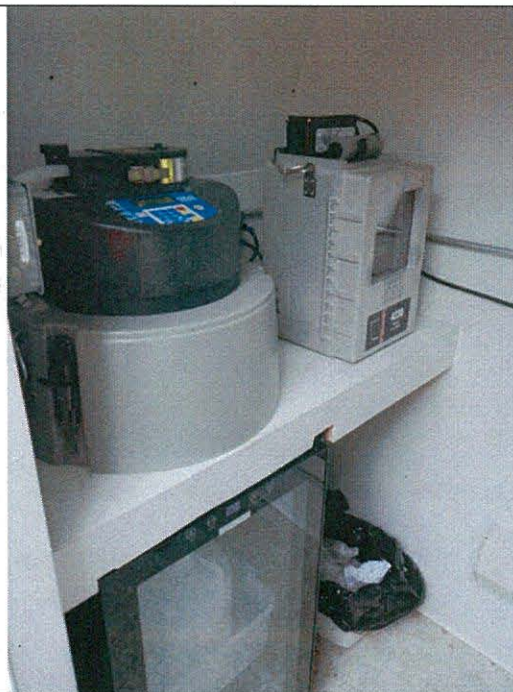
Photo #:12

Samples for effluent monitoring are collected using an ISCO 6712 composite sampler with flow-proportioned control from a ISCO 4230 flow meter. The facility utilizes two labs for analytical that is required by the permit Nautulis Lab is used for WET testing and Silver Valley Lab Analytical, Inc. (SVL) conducts the metals and E. coli. Brooks Rand Labs conducts their low-level mercury.

Description: Photo taken of refrigerated ISCO sampler that serves Outfall 003.

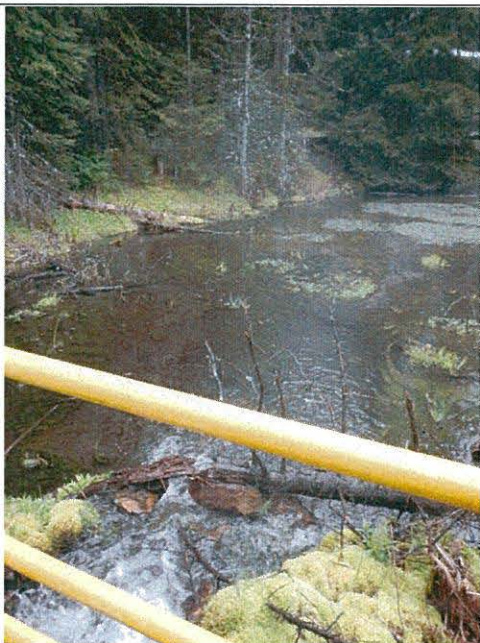
Photo #:13

Description: Photo taken from the location of Outfall 003, discharging at the time of inspection.

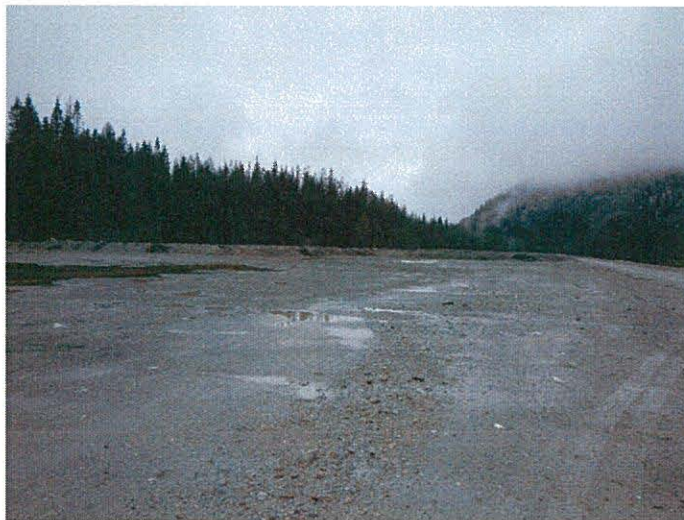
Photo #:14

Tailings Pond 3 (TP3) hasn't received tailings since 2010 and Lucky Friday has initiated steps for a closure plan for TP3 with IDEQ. Routine inputs to TP3 consist primarily of wastewater treatment residuals as well as water collected from the lower bench on the southeast tow of the embankment. As mentioned above, in 2015 Lucky Friday completed a multi-year hydrogeologic investigation at Tailing Pond 3 (TP3) in response to a 2013 Request for Information from EPA.

Description: Photo taken from TP3, facility has submitted draft closure plans to IDEQ.

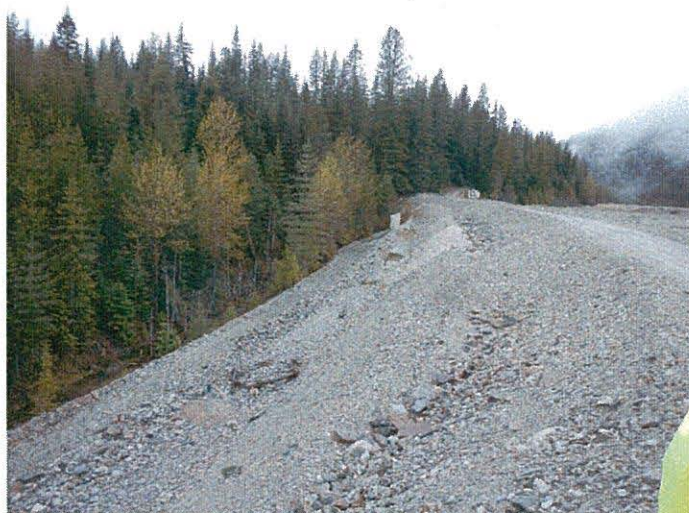
Photo #:15

Description: Photo taken of the southeast bench of TP3. Location of the recent hydrogeologic study.

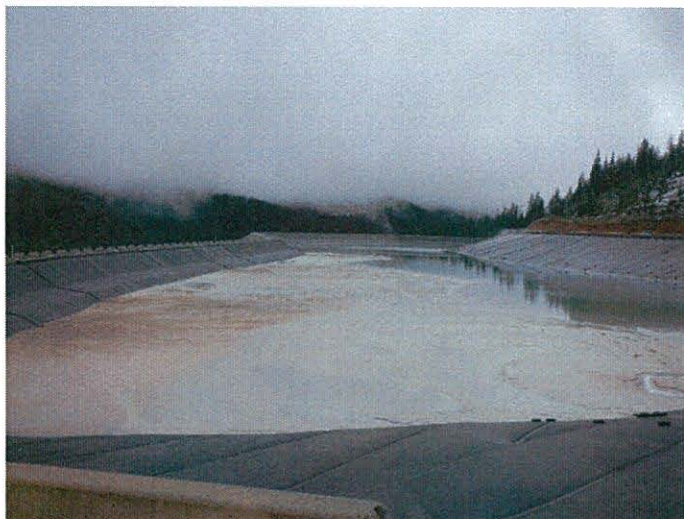
Photo #:16

Tailings Pond 4 (TP4) is the only pond that receives tailings when operating, and due to the inactive status of the mine at the time of inspection it last received tailings in March of 2017.

Description: Photo of TP4 at the time of inspection.
